LOWER CONNECTICUT RIVER BASIN
BERLIN , CONNECTICUT

KENSINGTON DAM CT 00250

PHASE I INSPECTION REPORT
NATIONAL DAM INSPECTION PROGRAM

FEBRUARY 1979

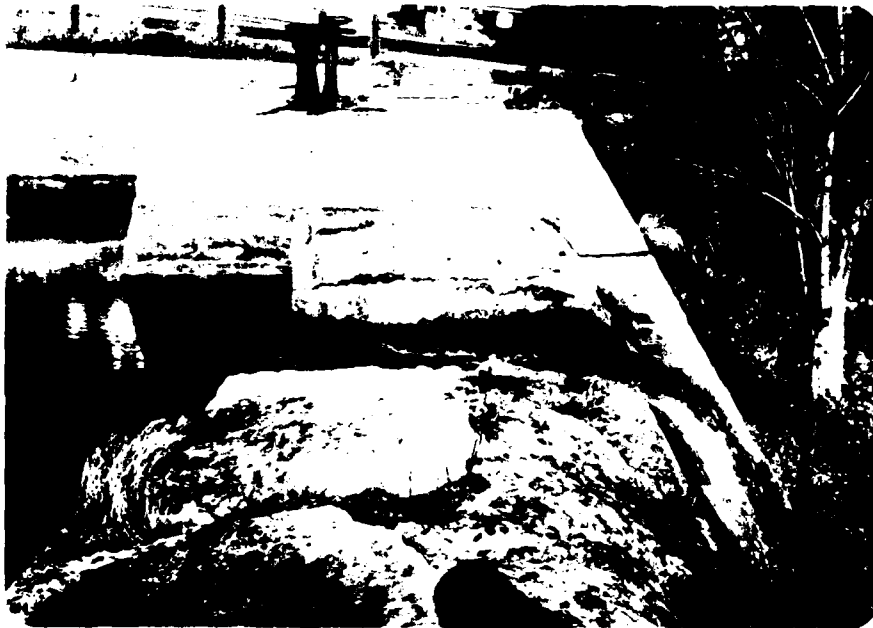
The spillway (Photo 1) is in poor condition having been partially removed by jackhammering for a distance of approximately 16 feet to a maximum depth of 3 feet. The crest of the spillway for the remainder of its length is intact although an attempt was made to remove it by jackhammering downstream of the crest. The attempt was abandoned while this portion of the spillway crest was still intact.

The inlet gate structure is located immediately to the left of the spillway on the upstream side of the dam. The hand-crank pedestal lift which operates the right gate is operable and feeds the low level outlet, shown in Photo 2. The hand wheel lift to the left gate is cracked and presently inoperable. Photo 1 shows the cast iron gate operating mechanisms.

A concrete retaining wall extends from the left abutment of the dam westerly along the shoreline of the lake and adjacent to the roadway above it. The concrete wall is cracked and spalled near the top as shown partially in Photo 1, as well as near the water line adjacent to the dam. The cracking at the water line is in both the horizontal and vertical direction, and appears to be up to 0.5+ feet deep. It is possible that contact seepage emerging on the downstream face of the dam could be due, at least in part, to infiltration through the observed cracking, and through any unseen cracking below the water level.

Of the two existing hand operated gates, only the right gate feeding the 42 inch cast iron low level outlet is operable. (See Photo 1.) The gate is opened a maximum of one foot during major storms or when the water level rises to the original elevation of the spillway. Usually the gate is opened only two or three times a year, as the lack of trash racks causes concern that a log or other debris could block up the gate and prevent it from being closed.

PHOTO NO.1 - Spillway cutaway, gate valves, and upstream concrete retaining wall.

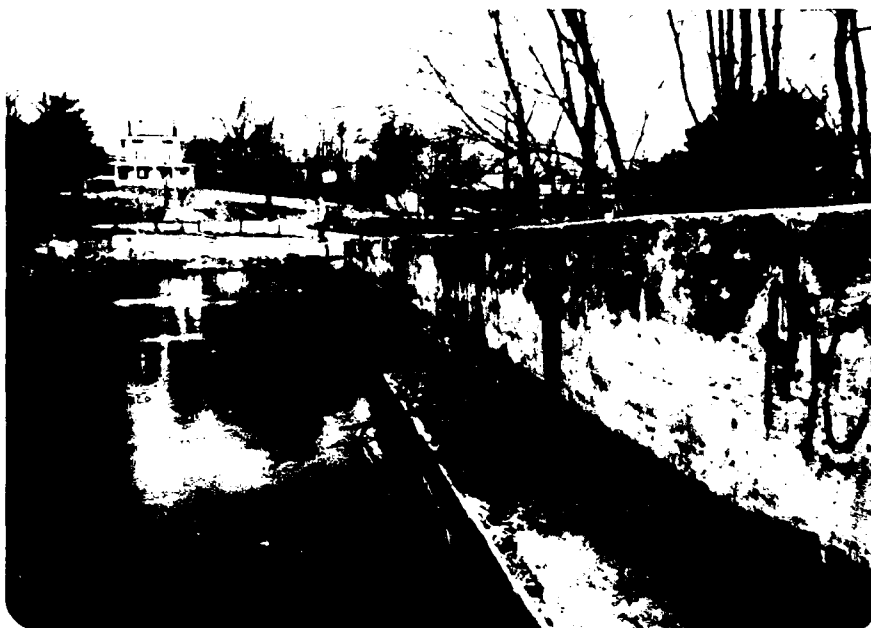
The upstream face of the dam also exhibits cracks, the worst area being near the right and left abutments. Near the right abutment, a horizontal crack up to 0.4 feet in depth exposed the interior concrete of the dam. At the time of our field investigation, this crack was above the water line. Any cracking below the water line was not observable. Refer to Photos 7 and 8 for views of the upstream face from the right abutment. Cracking of the upstream face of the dam was also observed adjacent to the left abutment.

PHOTO NO.7 - Upstream face of right section of dam with horizontal cracking.

2. An engineer qualified in dam design and inspection should investigate the cracking of the dam and the left upstream retaining wall, and recommend methods of sealing the upstream cracks in the dam and retaining wall against seepage. The engineer should also develop a system of monitoring the seepage both through the dam and along the contact with the left dam abutment. The seepage should be monitored monthly (complete with photographic records) to ascertain the volume of flow, the degree of silt transport, especially along the contact with the left abutment, and the development of any new seepage. Turbidity of the water, appearance of new seeps, or substantial changes in flow not related to changes in the lake level should be considered as possible indications of an unsafe condition. Should any of these occur, the engineer should investigate the problem to determine any required actions.
